Manhole Inspection Summary

Manhole # S33S__012MH

Inspection ☐ Is Incomplete Rating: **4) Poor**

Location Address: **100 w ostend st**

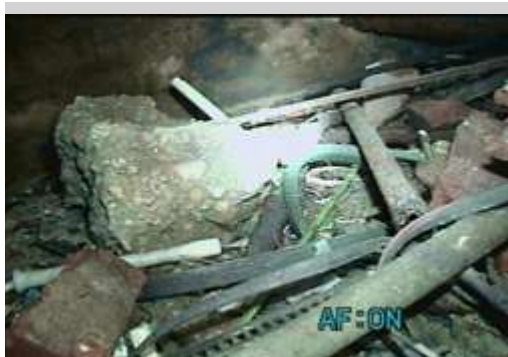
Defect 3

Condition: ☐ Sound ☐ Cracked ☐ Root Intrusion ☐ Deteriorated ☐ Leaks ☒ **Debris**

channel debris

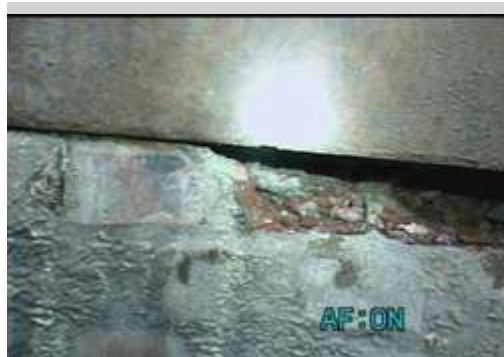
Defect 2

Condition: ☐ Sound ☐ Cracked ☐ Root Intrusion ☒ **Loose Brick** ☐ Deteriorated

loose bricks, frame adj

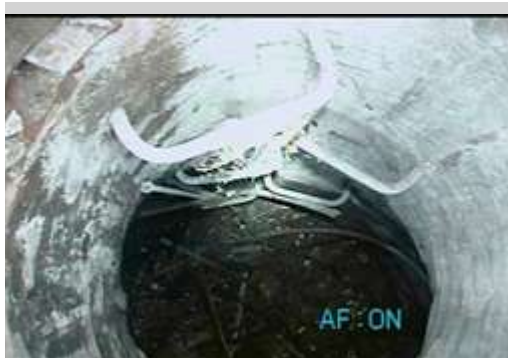
Defect 1

Steps Count: **5** Missing: **0** ☒ **Corroded**

cor. steps
